**NBSIR 80-2134**

# **Fire Performance of Selected Residential Floor Constructions Under Room Burnout Conditions**

J. B. Fang

Interim Report

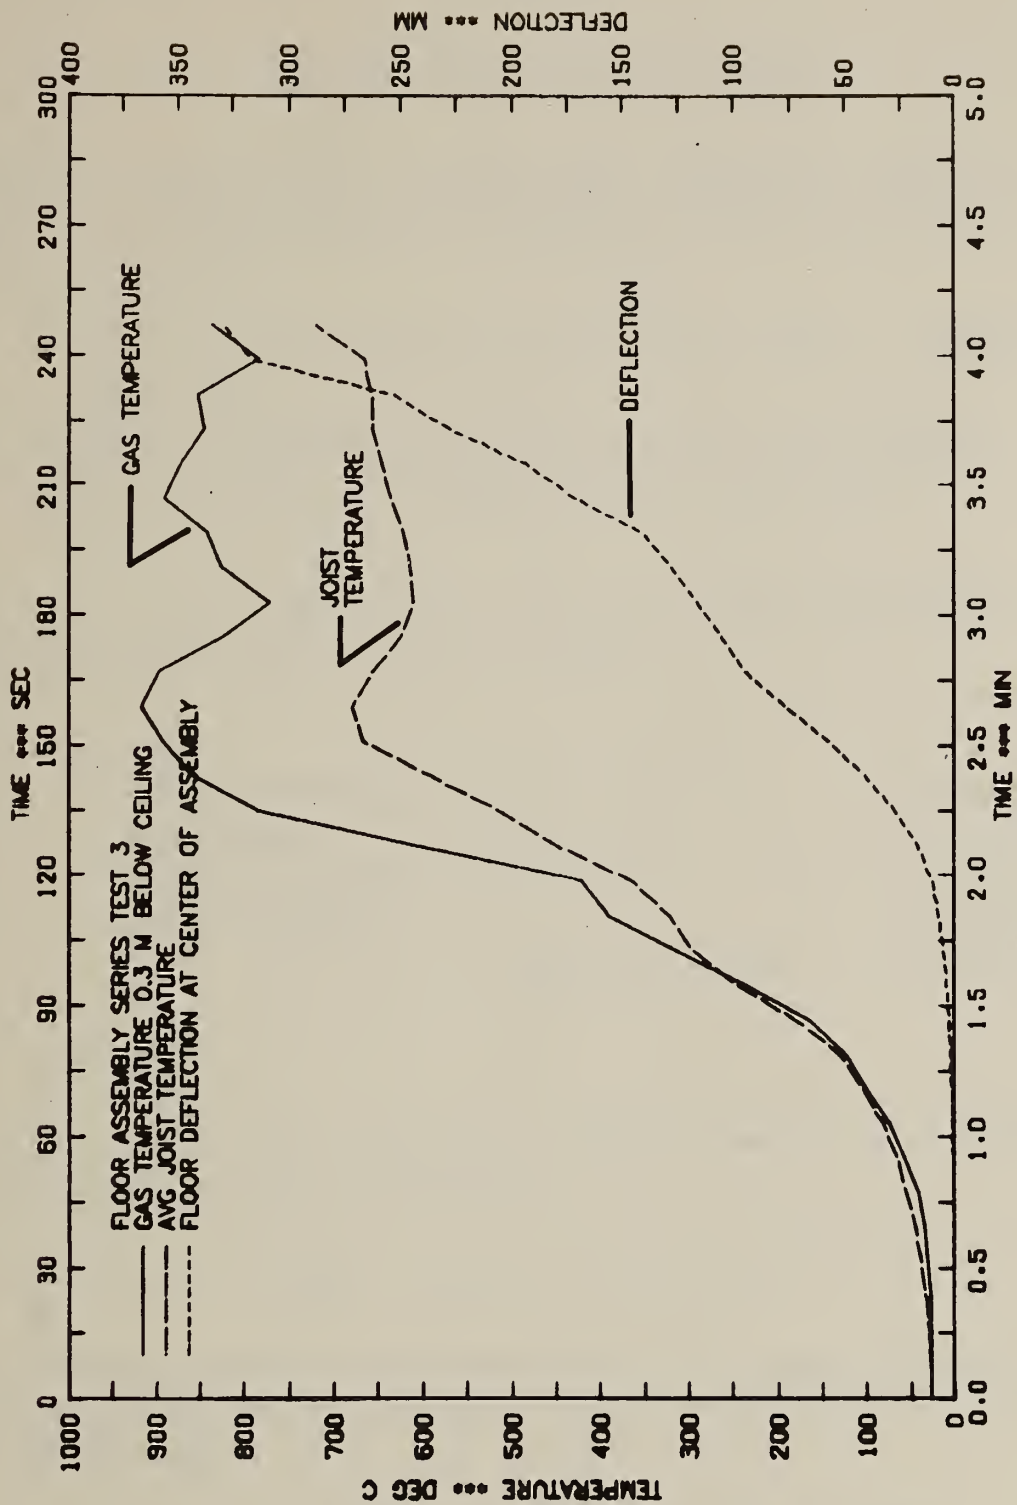
Figure 26. Relationship Between Floor Deflection and Temperature of Surrounding Gas and Steel Joist Temperature

The variations in time of the central deflection of the test assembly and the temperatures of the steel joist and room gas located along the vertical centerline of the test room for test 3 are shown in figure 26. As shown, the temperatures attained in steel member closely followed the temperature levels of surrounding gas, which depended upon the fire process. This was attributed to small thermal inertia because of the relatively high thermal conductivity and small thickness of steel joists used in the assembly. Also shown in the figure, the floor deflection increased with an increase in the joist temperatures.
